Assessment of waste dumping practices in mountain creeks

Konferenzbeitrag / conference paper

ASSESSMENT OF WASTE DUMPING PRACTICES IN MOUNTAIN CREEKS

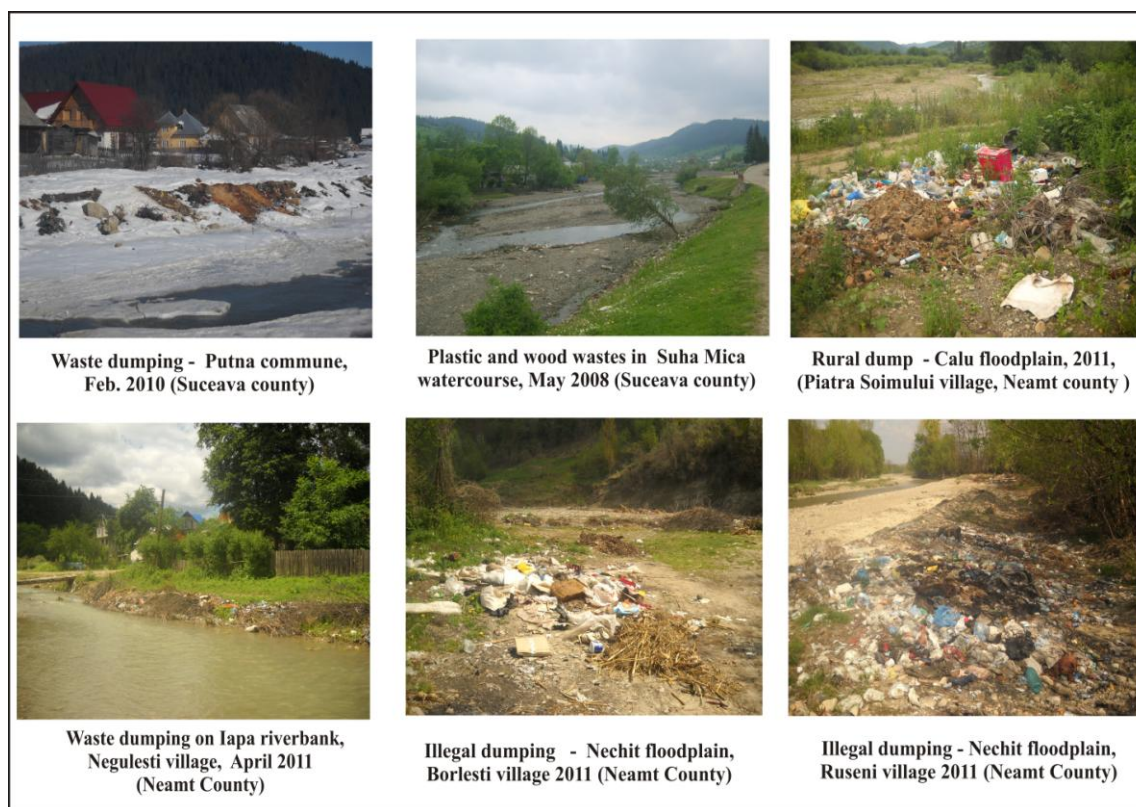
Figure 1. Waste dumping practices on mountain creeks (Eastern Carpathians)
